FAILURE INFORMATION

FLANGE SNAP-OFF

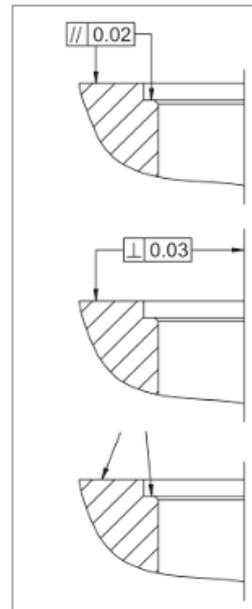
Figure 1

The flange of the cylinder liner is snapped off at the bottom with an angle from bottom to top as seen in Figure 1.

- One of the most important considerations during assembly of the cylinder block and the cylinder liner is that the seats and the contact surfaces of the flange should be parallel. If the surfaces are not prepared within the given tolerances, the flange is snapped off.
- If there is dirt between the surfaces where the cylinder block and the cylinder liner flange contact each other, force is applied onto the flange upon tightening the cylinder head bolts after assembly of the liner.

- If the cylinder head gaskets recommended by the engine's manufacturer are not used and the sequences and torque values of the cylinder head gaskets are not followed, the cylinder liner flange is snapped off.

- If the height between the surface where the gasket contacts and the cylinder liner flange in the engine block is not appropriate, vibration occurs in the liner with the piston movement due to this gap. The liner flange is snapped off due to the impact of the force caused by the vibration.

- While performing the assembly, the outer surfaces of the cylinder liner and the surfaces where the liner contacts in the engine block should be cleaned as recommended.
- You should make sure no dirt-burr remains there.
- If the flange seating surfaces are inaccurate, the given measurements should be taken into consideration during correction and there should be a chamfer of 0.5 to 1 mm width under 45° angle at the corners. (Figure 3)
- The importance consideration in assembly of the cylinder liner to the cylinder block is that the contact surfaces of the housing and the flange should be parallel to each other.
- Since it is not possible to observe the changes in

- Recommended gaskets should be used.

- The tightening sequence and the torque values should be taken into consideration.

- In order to avoid the oscillation movement of the cylinder liner inside the housing;

1. During rectification of the engine, while processing the cylinder block, adequate number of steel shims should be placed under the cylinder liner flange.

2. Or liners with flanges longer than standard values should be assembled.

The height difference between the block and the top point of the flange should be checked after the liner assembly.
