FAILURE INFORMATION

ASYMMETRICAL WEAR PATTERN ON THE PISTON SKIRT

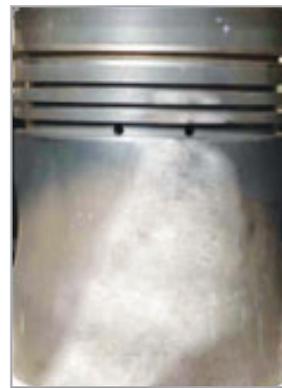
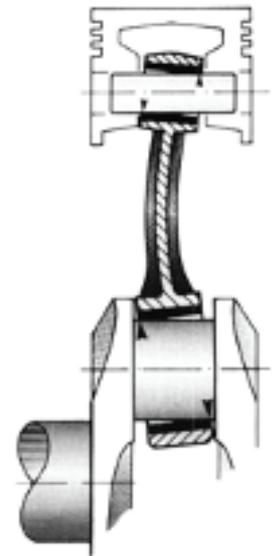
Figure 1

- There are marks of asymmetrical operation at the contact surface of the piston skirt. (Figure 1)
- There are accumulations of soot on the piston crown and in the piston ring grooves.

The cause of the failure is that the piston is in inclined position inside the cylinder. Whereas one side of the piston operates facing the liner, the other side operates without facing it. The pressure, which occurs as a result of ignition, leaks from the area, which does not contact the cylinder surface, towards the crankcase. The piston rings cannot hold this pressure as the pistons are inclined, and they cause pumping of oil into the combustion chamber. The causes of the pistons operating in inclined position inside the cylinder are;

- The piston rod is bended or buckled.
- Bushing groove of the piston rod is turned on an inclined axis.
- Inaccurate assembly order and inaccurate tightening values are applied.
- Space of the rod groove in the piston rod is more than necessary.
- There is dirt on the air-cooled cylinder base. Therefore, the cylinder is inclined on the engine block. Therefore, the pistons operate in inclined position inside the cylinder.

1. The crankshaft and the connecting rod should be machined coaxially during overhauling of the engine and the assembly should be made coaxially.
2. Cylinder head studs should be tightened at the value and in the sequence recommended by the manufacturer.
3. Rod bearing spaces should be checked. Bearings with inaccurate space measurements should not be used.
4. A special importance should be placed on cleaning during assembly of the engine and the seal remainders should be carefully cleaned.
5. Inclination of the connecting rod should be checked during engine overhauling and the inclined connecting rod should be replaced with a new one.
