FAILURE INFORMATION

SEIZURE ON THE PISTON SKIRT

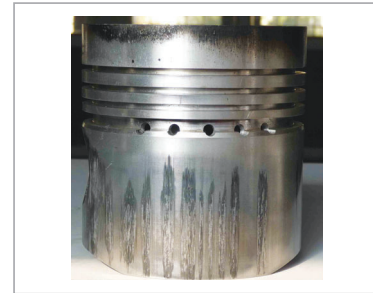
As the image of the pistons removed from the engine is seen in Figure 1, there are marks of seizure with specific intervals only at the skirt area.

Such failures usually occur in a short time following the engine overhauling operation.

There are two causes for the piston to fail in a manner similar to the image in figure 1. These are;

1-Seizure due to lack of space resulting from excessive heating

The space between the Piston and the Liner is reduced due to a failure and problem in the cooling system of the engine. Since the aluminum piston expands 2 times more than the iron cast, seizure failure shall occur in excessive forces and heats.

2-Seizure due to lack of space resulting from Manufacture and Assembly defect

The amount of space between the piston and the liner is reduced as the inner diameter of the cylinder is not processed properly.

3- Faulty engine overhauling operation

The engine cover is assembled defectively. The bolts of the engine cover are tightened more than the torque values recommended by the engine's manufacturer and the shape of the engine block is changed. In such failures, seizure occurs in the piston in the first housing of the engine.

1-Measurement of the piston and the cylinder should be checked for accuracy. The piston diameter and piston space measurements and cylinder diameter measurements stated on the piston crown should be adjusted.

2- Checks with regard to the cooling system should be performed.

- Thermostat
- Coolant water level
- Circulation pump
- Fan belt should be checked. (Worn, defective belt should be replaced.) Tension of the fan belt

should be in a manner to stretch for 1-1,5 cm. If it is more loose, the engine overheats.

- Air discharge must be performed and the air discharge system should be checked.

-Radiator cap and radiator cores should be checked.

3- You should take the air in the coolant water inside the cooling system.

4- Bolt torque values of the engine's top cover should be adjusted with the torque wrench at the values described by the engine's manufacturer.
