FAILURE INFORMATION

CAVITATION AND PITTING ON THE CYLINDER LINERS

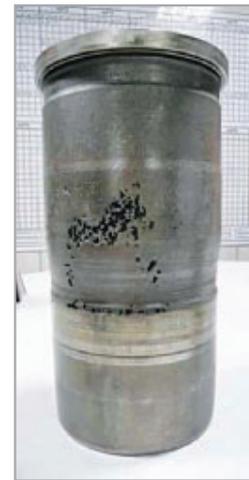
Figure 1

In wet-type cylinder liners, holes and pittings occur in the areas where the liner contact with water, as seen in the figure. (Figure 1)

If the cylinder liner does not properly fit the cylinder block or if it is loose for the cylinder piston dimensions, the explosion at the ignition causes vibrations in the cylinder liner. These vibrations affect the flow of the coolant fluid. In this way, the cooling film on the outer surface of the liner is eliminated at certain areas. Steam bubbles occur on the surfaces, where the cooling film is eliminated, due to low pressure and high temperature. The steam bubbles start to hit the surface, where the film is not present in the liner. Due to the force applied by these bubbles, pieces snap off from the surface, holes and even pittings occur.

- It occurs when used pistons are used again. Used piston is not appropriate for new cylinder liner, it is worn away and a space remains between the cylinder liner and the piston.
- Anti-corrosion materials added into the coolant fluid are not adequate.
- Fluids containing inappropriate coolant fluids (acid water, lime water, sea water or fluids containing hazardous materials) are used.
- Since the thermostat is faulty, the engine cannot reach the required operating temperature and the cylinder and the piston cannot reach the

required temperatures. Therefore, the required expansion cannot be achieved and a space occurs between the piston and the cylinder liner. This space causes steam bubbles and pittings.

- In order to keep the pressure of the cooling system at the required level in the engine block, pressurized radiator caps are used. If the recommended radiator cap is not used, water leaks outside the system and as there is no adequate pressure, the boiling point of the water is reduced. The coolant fluid boils and steam bubbles occur due to the temperature of the cylinders.

- During the engine overhauling operation, the cylinder liner, the piston and the piston rings should be used as a kit and they should be replaced within the same operation. Used products should not be assembled to the engine again.
- Protective materials and anti-freeze should be added into the coolant fluid at the recommended level. Protective materials should be added continuously with small amounts as the vehicle is in use. Furthermore, the protective materials should be replaced in every two years.

- Inappropriate coolant fluids (acid water, lime water, sea water or fluids containing hazardous materials) should not be used.
- The radiator caps recommended by the engine's manufacturer should be used and inappropriate caps should not be assembled to the radiator upon third parties' recommendations.
